TECHNICAL REPORT ARCCB-TR-90009

# DENSIFICATION OF WEAPON CASTINGS

# US ARMY ARMAMENT RESEARCH, DEVELOPMENT AND ENGINEERING CENTER

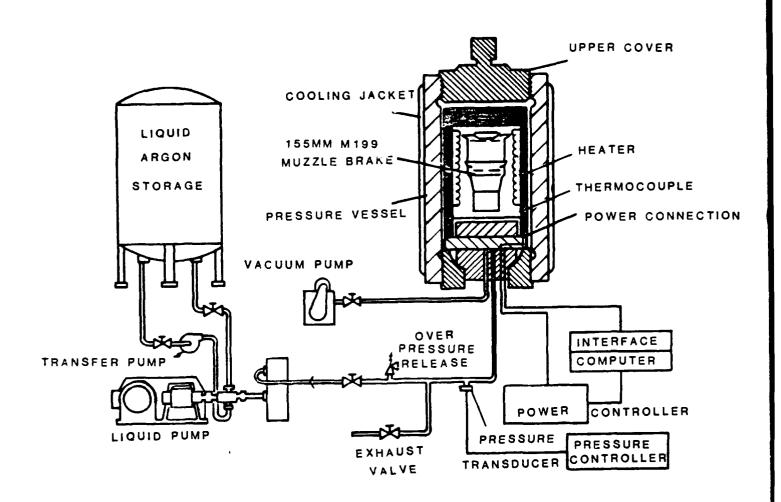
Figure 1. Simplified schematic of a hot isostatic pressure system.

HIP is used for the densification of castings to provide internal soundness, increase densities, and improve mechanical properties. The HIP process works as follows: components are placed in a pressure vessel containing an inert gas, e.g., argon, where they are subjected to the simultaneous application of a high isostatic pressure and high temperature. A typical HIP system is illustrated in Figure 1. Under these conditions, the material becomes plastic and any internal voids collapse by creating a pressure differential between the voids in the workpiece and its external surface. HIP removes internal voids, in effect transferring the voids to the surface where the "dimple" is formed and can be machined away.

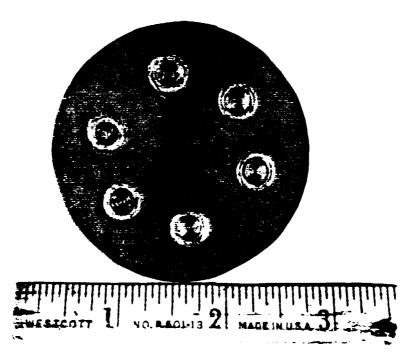
Figure 2b. Holes resealed by electron beam welding.

Four specimens were made utilizing 4130 barstock. These specimens are illustrated in Figures 2a and 2b, including two specimens which were sectioned from a 155-mm M185 muzzle brake casting as illustrated in Figures 3a and 3b. This test was carried out by producing (machining) holes of various diameters and lengths on both ends of a sound specimen (Figures 4a and 4b). The lengths and diameters of the holes are listed below in Table I.

These holes were then evacuated and resealed by electron beam welding to simulate internal porosity conditions in a casting. Radiography was conducted on all samples prior to hipping (see Figures 5a and 5b). The specimens were then hipped under several processing conditions to eliminate the various size pores. Time, temperature, and pressure data were selected to close the internal "flaws" of the specimens.

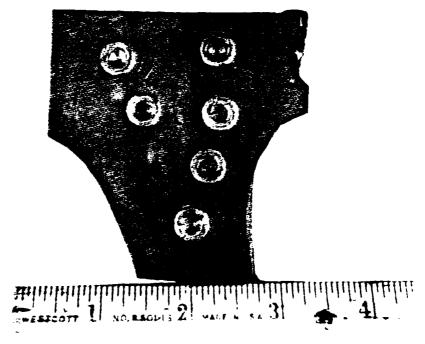
Figure 3b. Resealed holes on top surface of brake casting specimen.

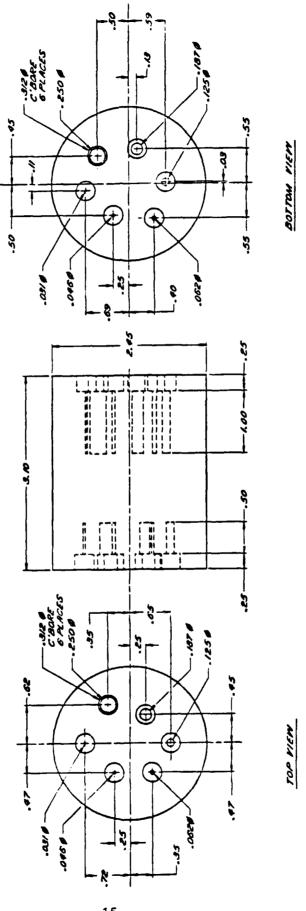
Figure 4a. Diagram of barstock showing machined holes.

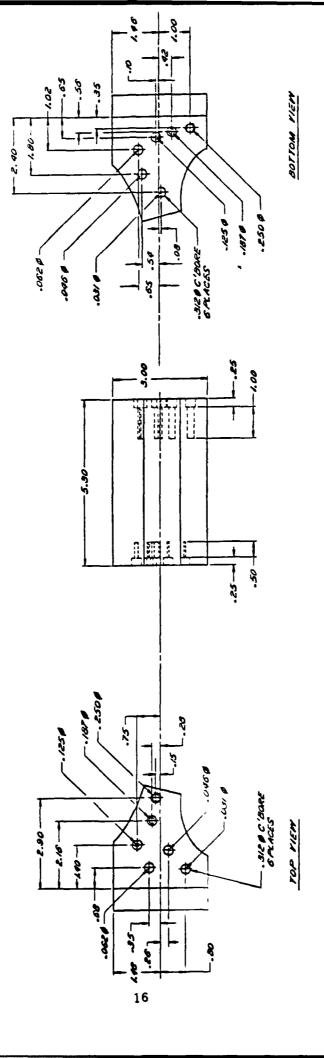
Figure 4b. Diagram of casting showing machined holes.

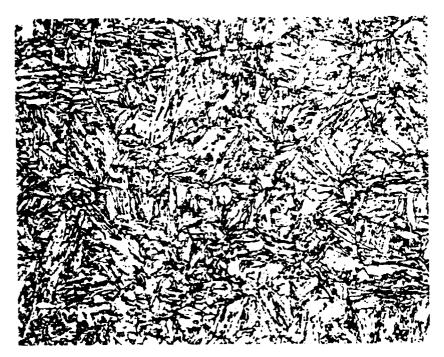
Figure 10a. No-HIP sample revealing a tempered martensitic microstructure (1000X).

Microstructural examinations were performed on the mechanical test specimens taken from the HIP and no-HIP muzzle brakes. A representative photomicrograph (Figure 9a) of the no-HIP samples reveals a material that contained shrinkage porosity, and was relatively large on a microscopic level with small globular oxide inclusions dispersed throughout the matrix. The HIP sample shows that densification was achieved on a microscopic scale, i.e., no evidence of shrinkage porosity (Figure 9b). Examination of the microstructures of both the no-HIP and HIPPED samples etched in 2 percent Nital shows tempered martensitic structures, Figures 10a and 10b. These microstructures are indicative of low alloy steel which has undergone quenching and tempering. The similar microstructures were attributed to the muzzle brakes, HIPPED and no-HIP, undergoing identical heat treatment.

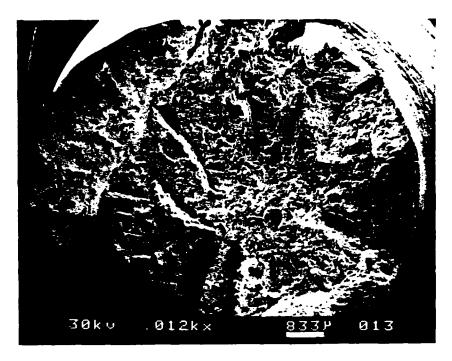
Figure 11a. Overall fractograph of HIP fracture surface (12X).

Stereoscopic and scanning electron microscopic (SEM) examinations were conducted on the fracture surfaces of the as-tested tensile bars from representative samples of the HIP and no-HIP muzzle brakes. The overall fracture surfaces of each are depicted in Figures 11a and 11b. The HIP sample fracture surface was a partial cup-cone fracture. It is a common feature of ductile fracture, occurring primarily by microvoid coalescence at the center of the bar and then by shear at the outside surfaces, and is manifested fractographically by dimples. Figure 11c shows the ductile fracture mode, referred to as dimpling, in the HIP sample.

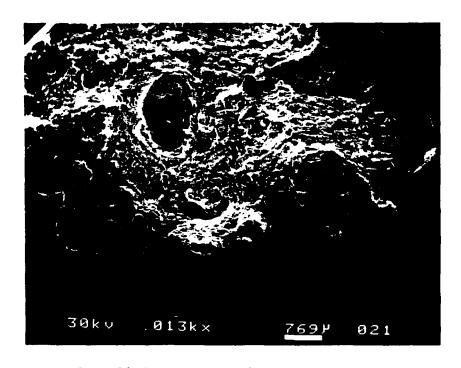
Figure 11b. Overall fractograph of no-HIP fracture surface (13X).

Fracture surface features of the no-HIP samples were much coarser. There was also evidence of secondary cracking below the fracture surface. Upon examination at higher magnification, shrinkage porosity was noted on the fracture

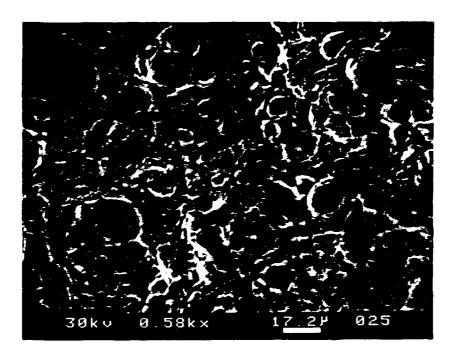
Figure 11c. Dimpling on the fracture surface of the HIP sample (580X).

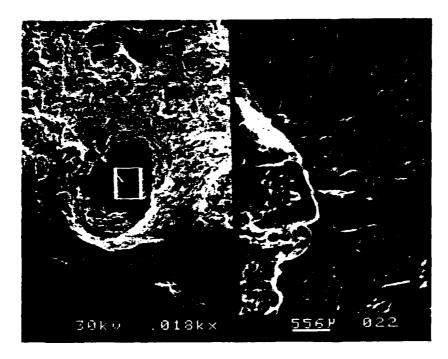
Figure 11d. Porosity observed on the fracture surface of the no-HIP sample at 18X. A magnified view of the pore at 180X.

surface with grain boundaries clearly visible inside these pores (see Figure 11d). The shrinkage cavities are a result of the solidification process.
